C-Cure Solutions

Treatment of Mercury and Heavy Metal Impacted Sites in Colombia

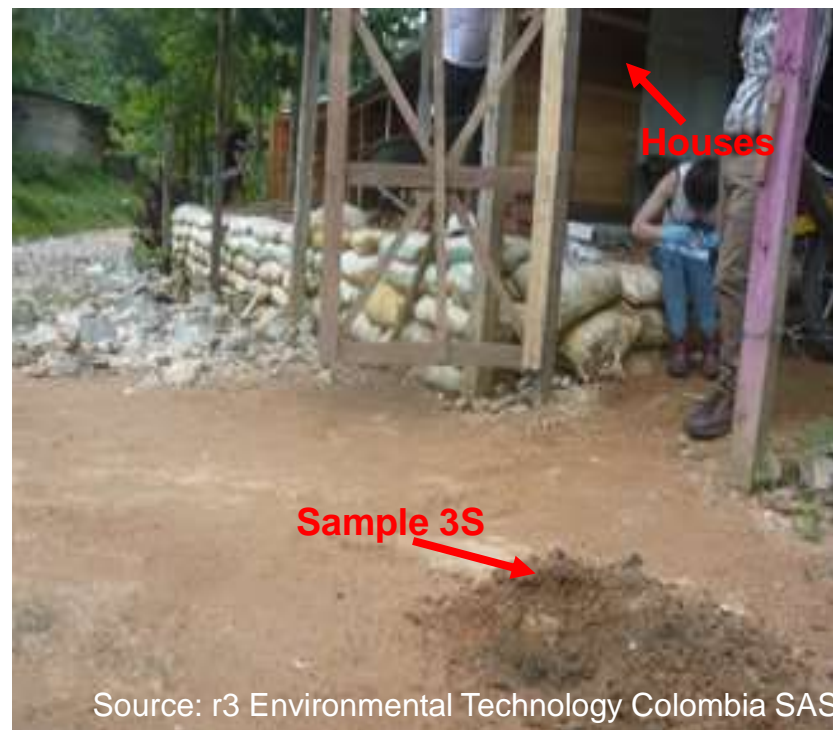
El Planchon Mine: Metal Contaminated Soil

Sample taken in El Planchon, crossing the creek downstream the processing plant, very close to the neighbouring town houses.

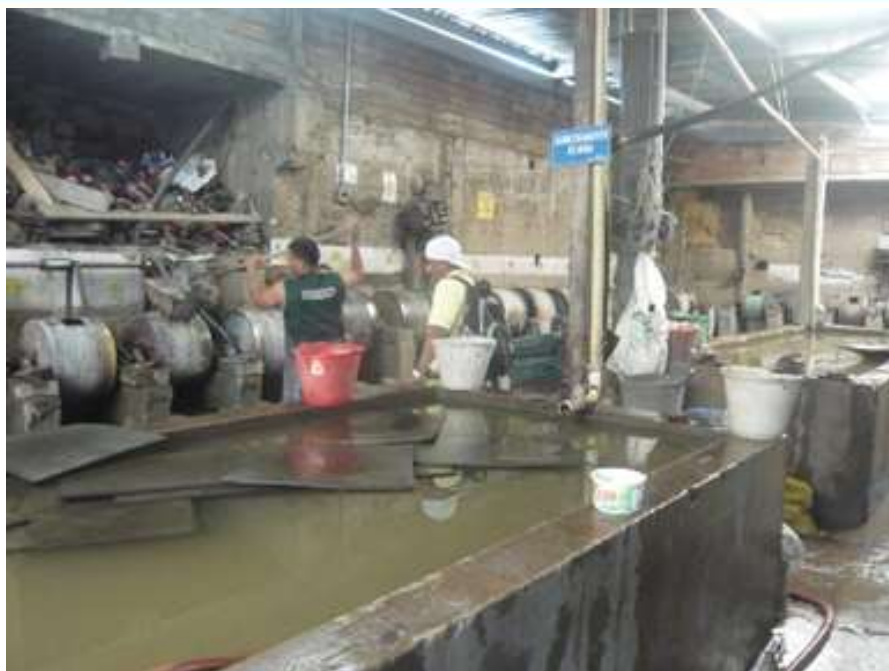
La Palma: Mercury Contaminated Tailings Waste

Benefit plant involved in the gold mining process in Segovia, Antioquia

Inside the processing plant La Palma, a pile of tailings emerging as a by-product of the plant is stored. On top of this stack, the dry solid sample was taken.

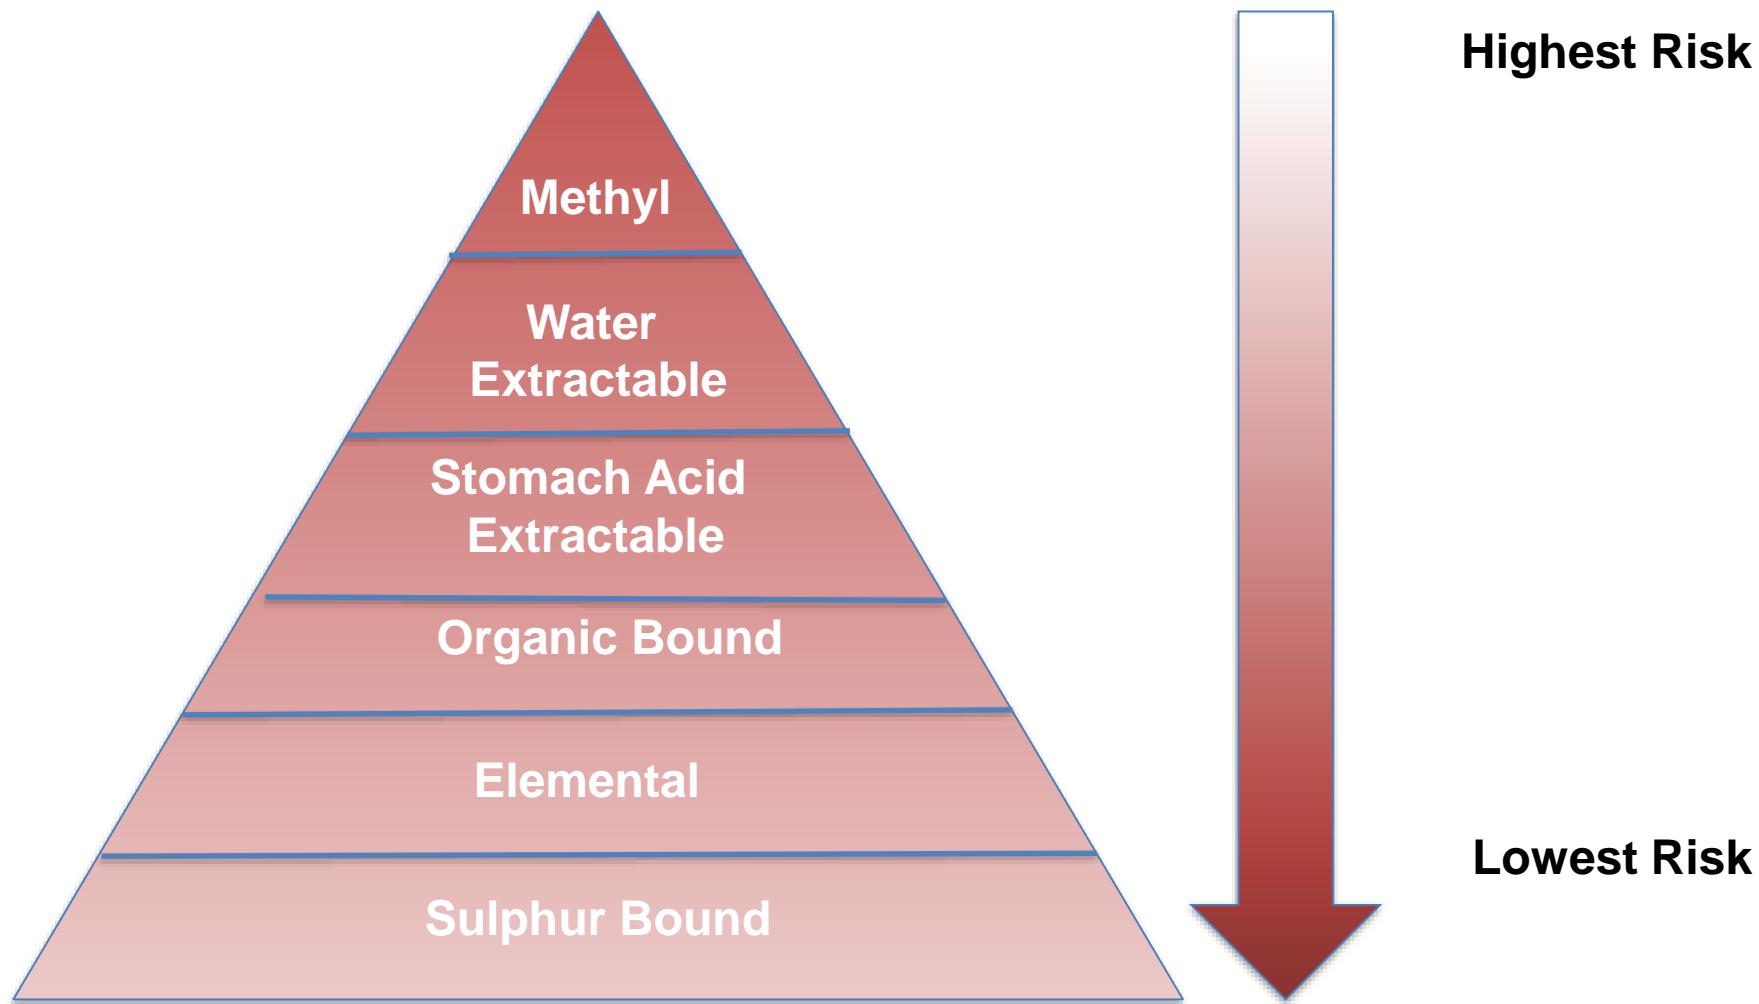
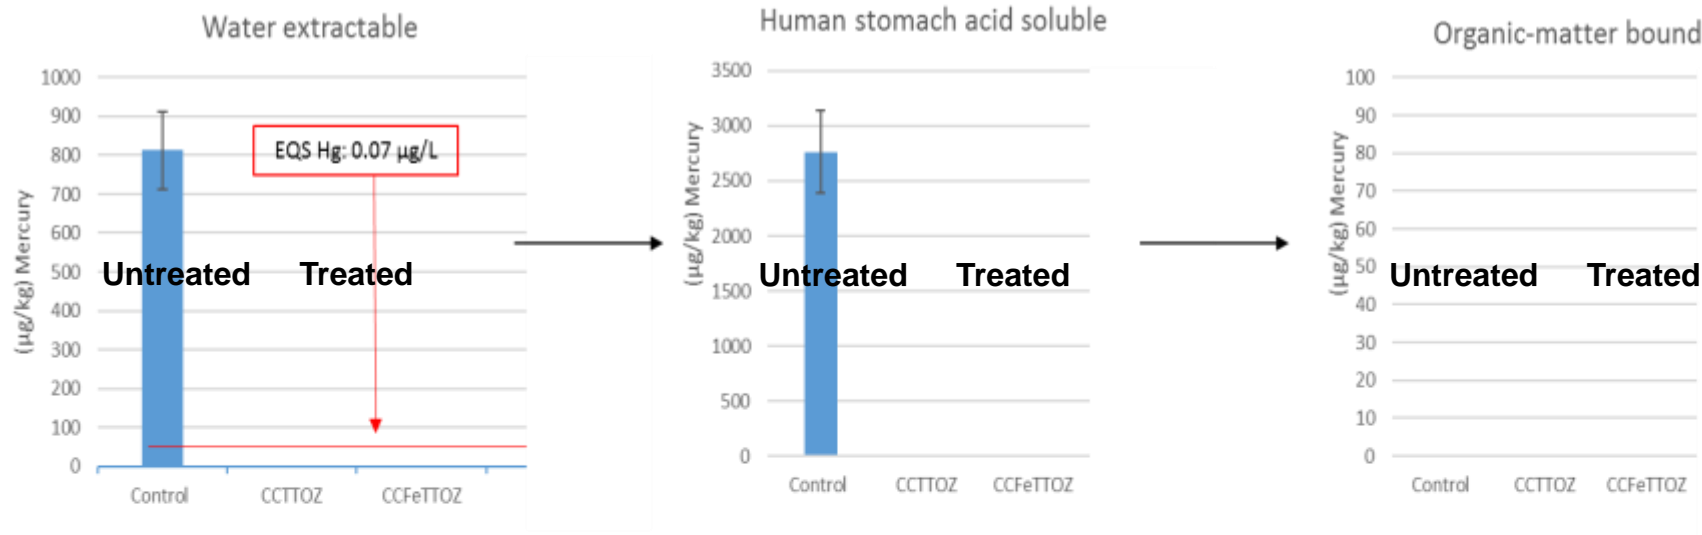
C-Cure Treatment of Mercury

- 5% (wt/wt) Treatment Rate
- Needs to be optimised i.e. treatment rate may be much lower
- Would reduce costs

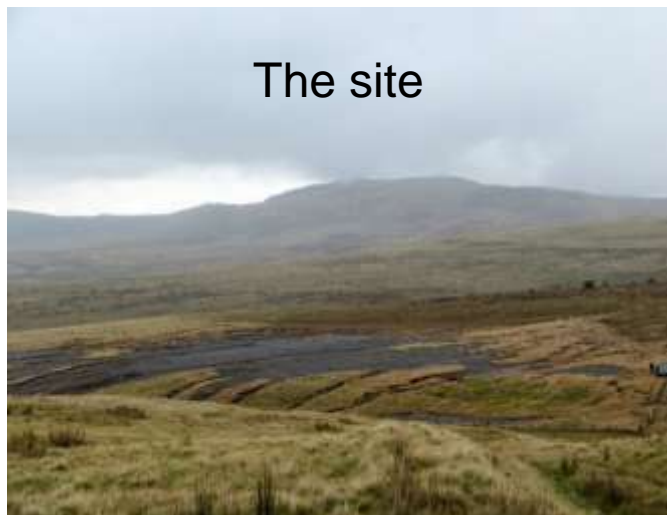
The site

Site causes contamination of river due to leaching, erosion and run-off

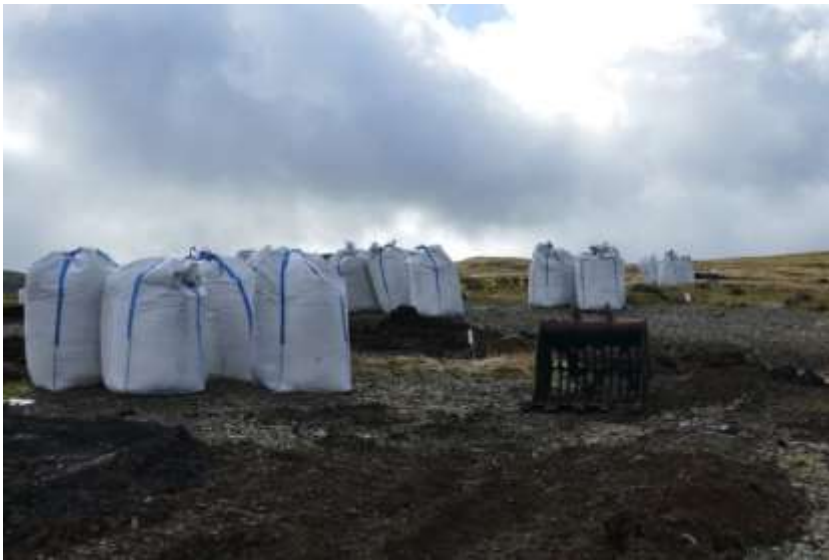
Sacks with C-Cure Product

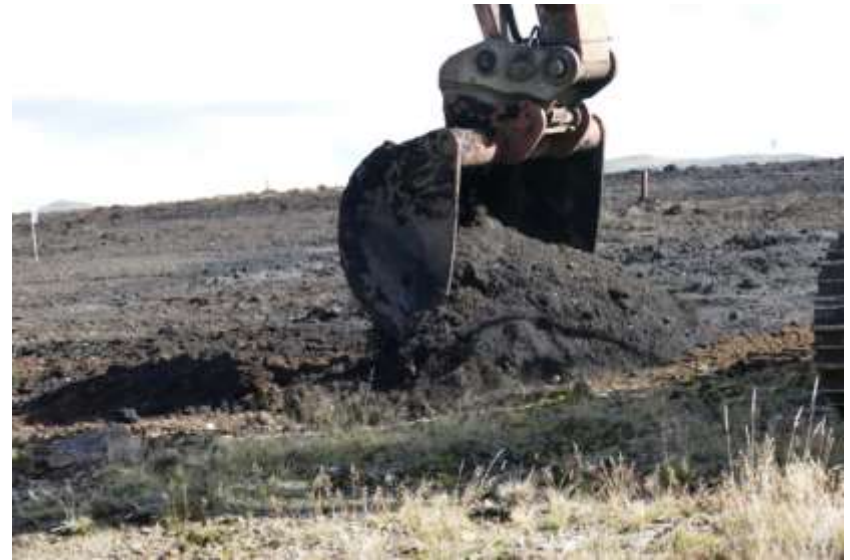
Incorporation of C-Cure Product

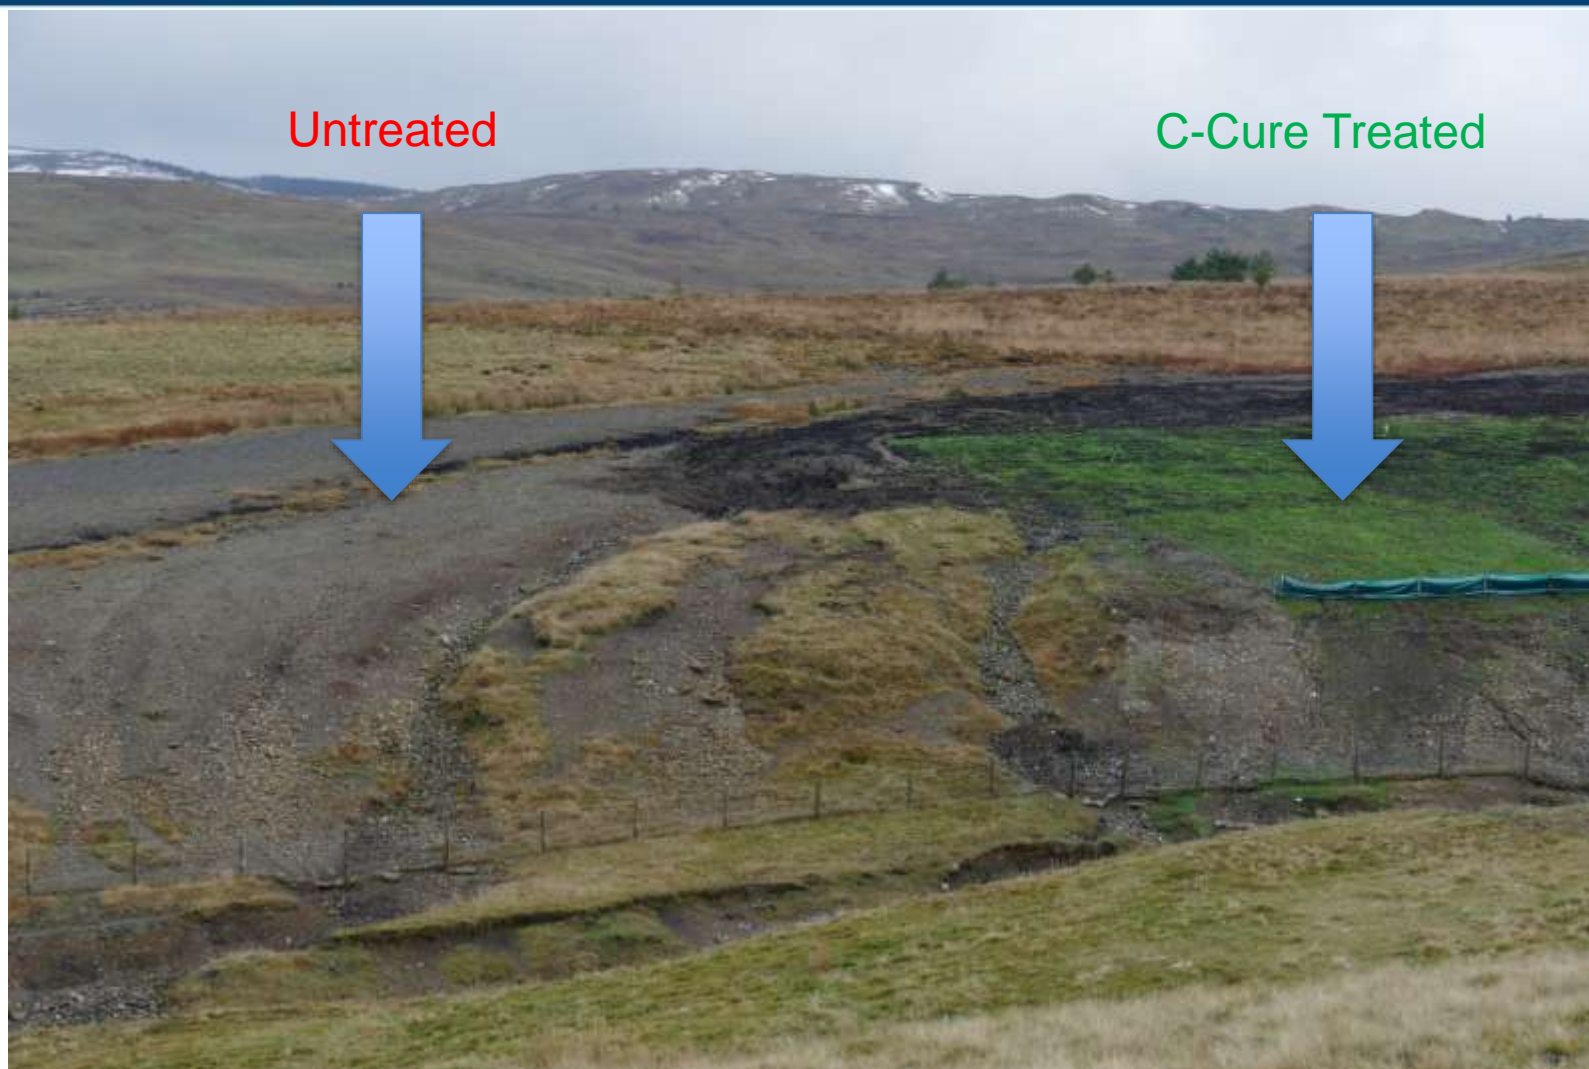
Site 2 Months after C-Cure Treatment

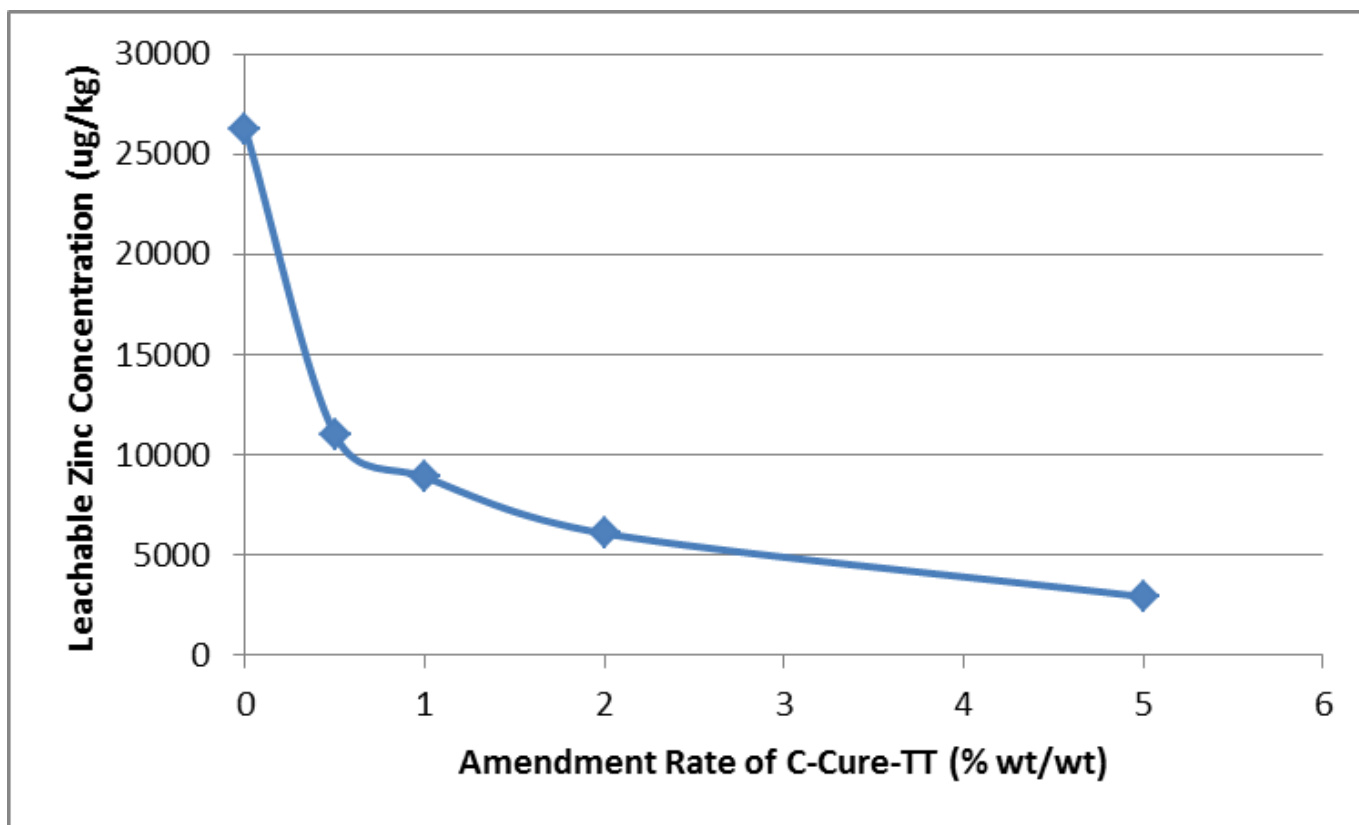
Effects of C-Cure Product on Leachable Zinc Concentrations

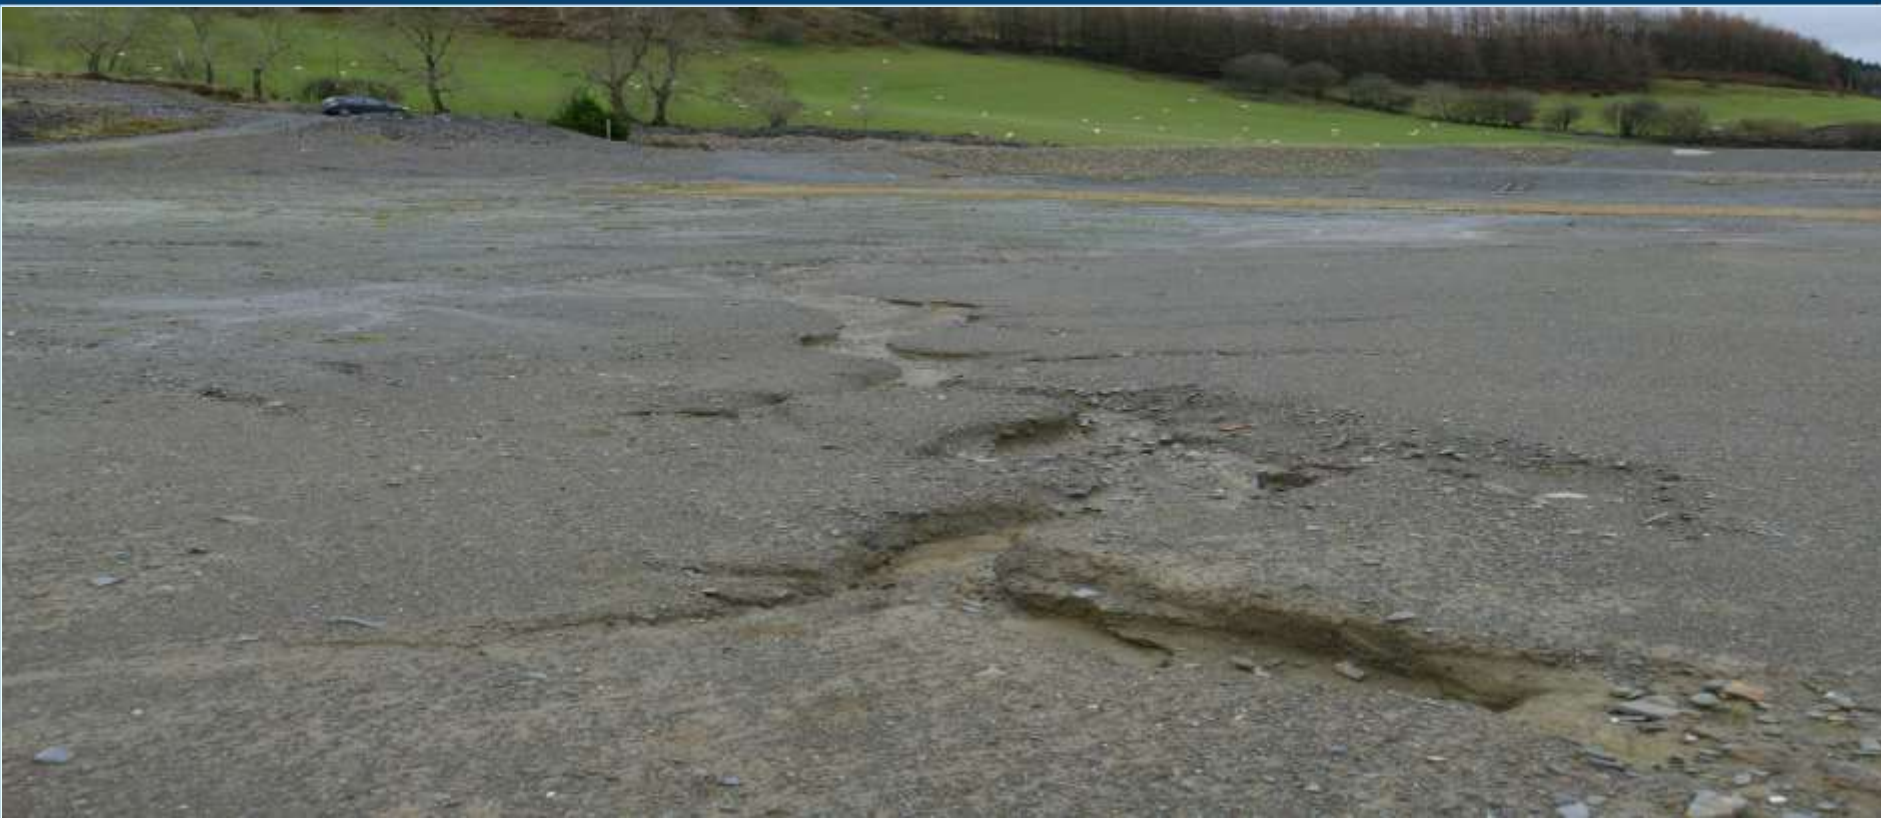
Former Lead and
Zinc Mine

- High concentrations of leachable heavy metals
- Low pH (5)
- No vegetation
- Extensive Gully Erosion

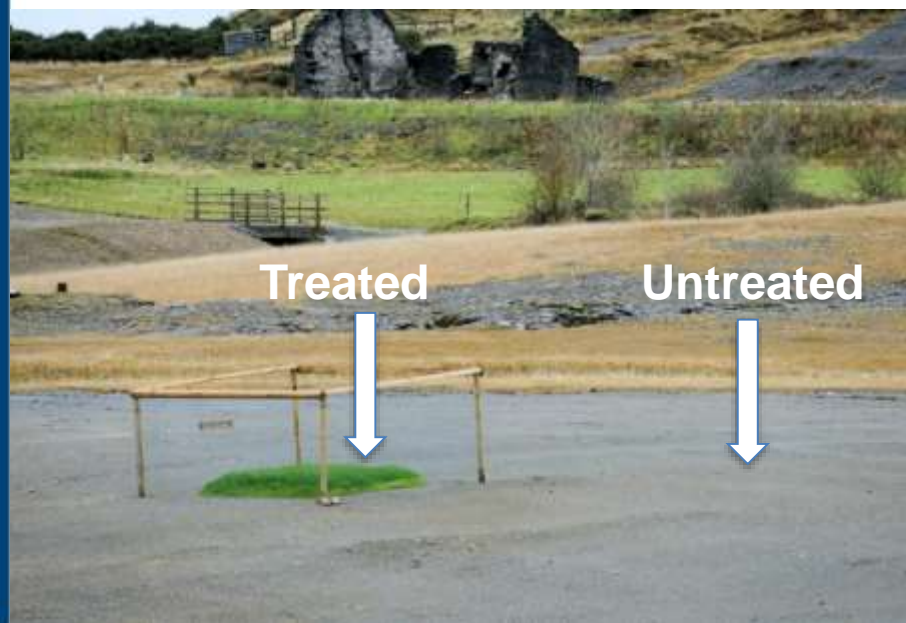
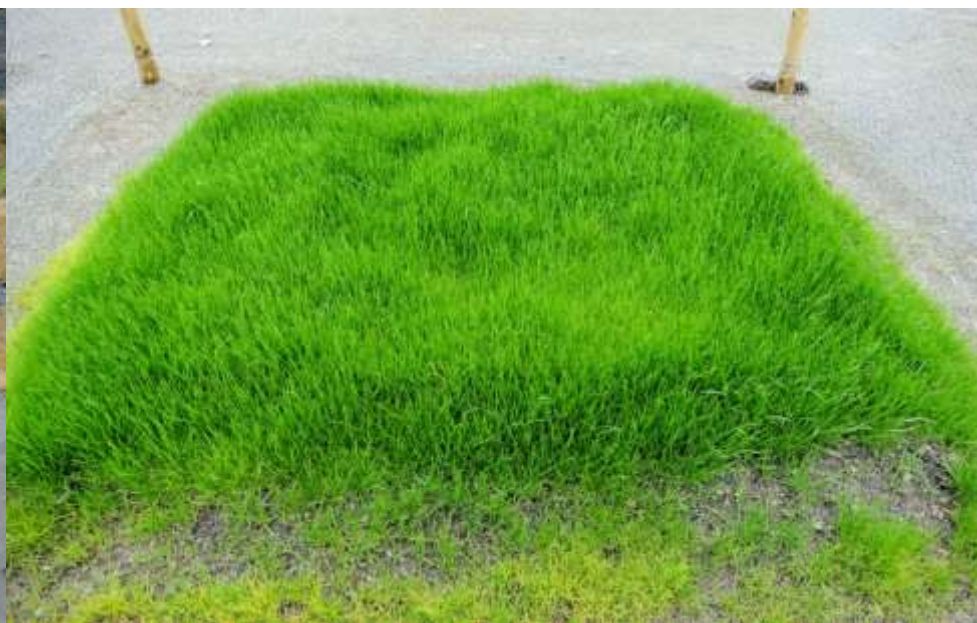
Treatment	Leachable Metals [mg/kg]			
	Cd	Cu	Pb	Zn
Untreated	0.34	3.01	160	127
C-Cure treated	0.01	0.05	11	3
% Reduction	97%	99.5%	93%	97%
